November 18, 2015  
**Tech Tip #48**

**Tech Tip is to alert STEMCO customers that there is an interference issue between the STEMCO 4195 (P-spindle) hubcaps and the Hendrickson Precision320 axle nut.**

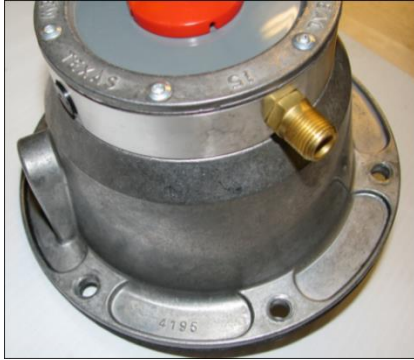
Typical STEMCO Aeris 4195 Cap

**To prevent this interference issue with the 4195 hubcap, Stemco recommends that the Precision320 Spindle nut be replaced with the STEMCO Pro-Torq Nut part number 447-4723.**

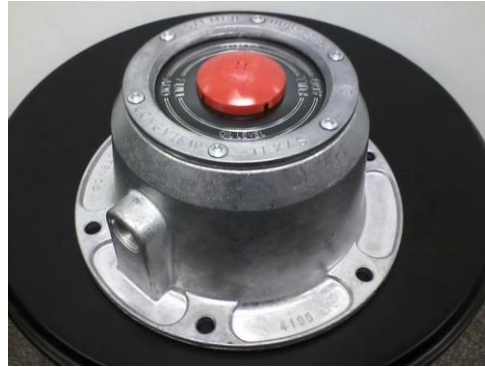
Typical STEMCO Standard 4195 Cap

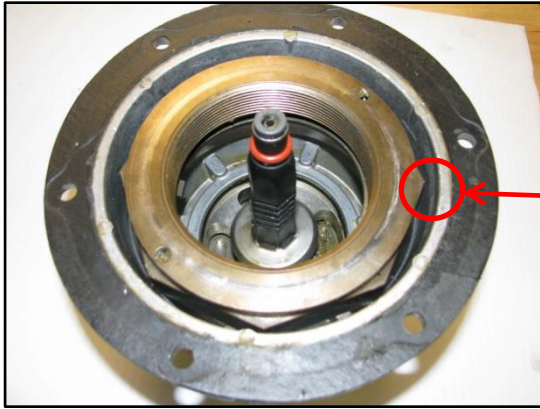
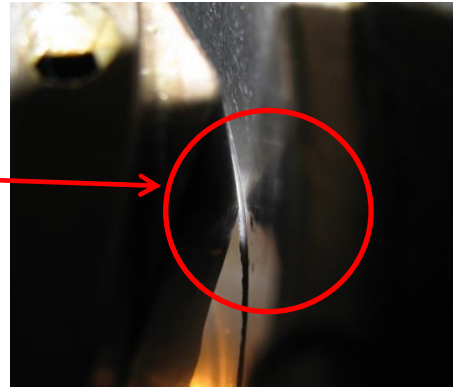
Hendrickson axle nut and 4195 Cap

**Quote from the T77001 document:** *“While some early production nuts were machined from steel, the current nut design utilizes powdered metal construction and is slightly thicker than the steel nut it replaces. Using the larger powdered metal nut in applications for which it was not intended can result in interference with the hubcap”*

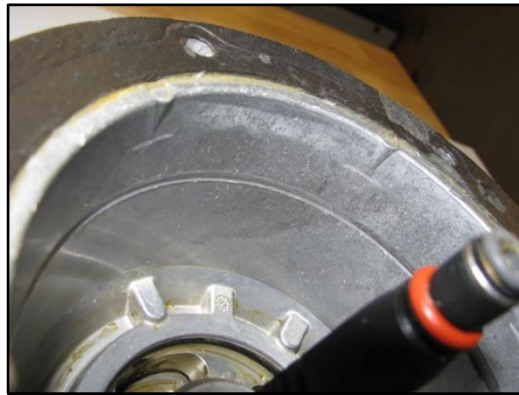
Interference occurs between the axle nut and hubcap, cutting into the hubcap wall
