STEMCO TrailerTail® AutoDeploy™ Electric Latch Sealant

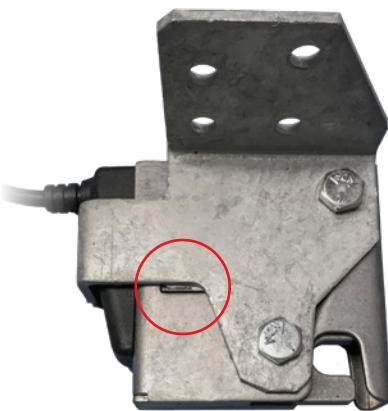
Top of Latch

The images below show how to identify the old latch revision from the new. The latch motor is exposed through two windows in the latch case. If you can see a white line in either of those windows, then the latch is a new revision and must be returned to STEMCO to undergo testing prior to being approved for warranty.

In 2014 STEMCO released a new AutoDeploy™ electric latch with an enhanced latch motor sealing system. We had seen a few returns of electric latches with moisture in the motor and wanted to ensure our customers were receiving the highest quality and most durable product. If you have a failed latch with the older sealing system, we simplify the warranty process by only requesting photos of the latch to verify that no white sealant is present. We do not require returning these old latches to STEMCO for warranty approval.

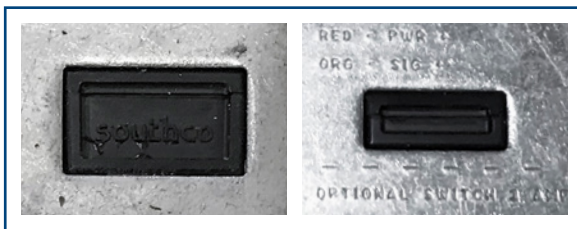
Previous Black Seals

Do not go out and replace all old latches; the failure rate we have seen is very low and the latch is unlikely to fail in the lifetime of the trailer.

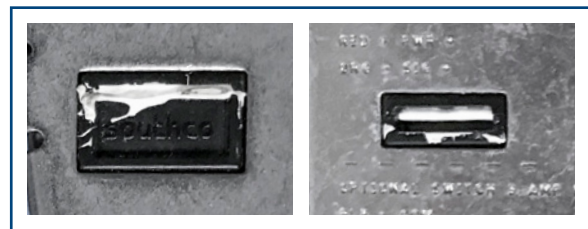
New White Sealant
